John Jefferys, London; a watchmaker of repute, but did he actually make longcase clocks?

A clock in poor condition

After the repairs and restoration work

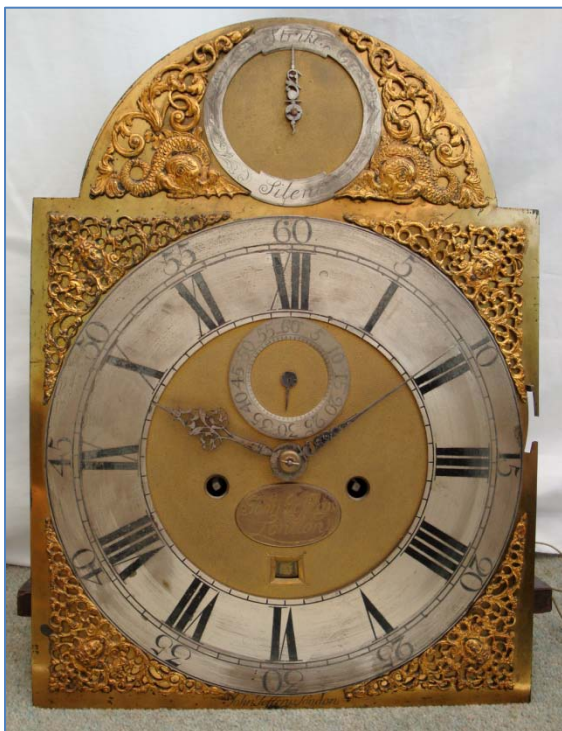
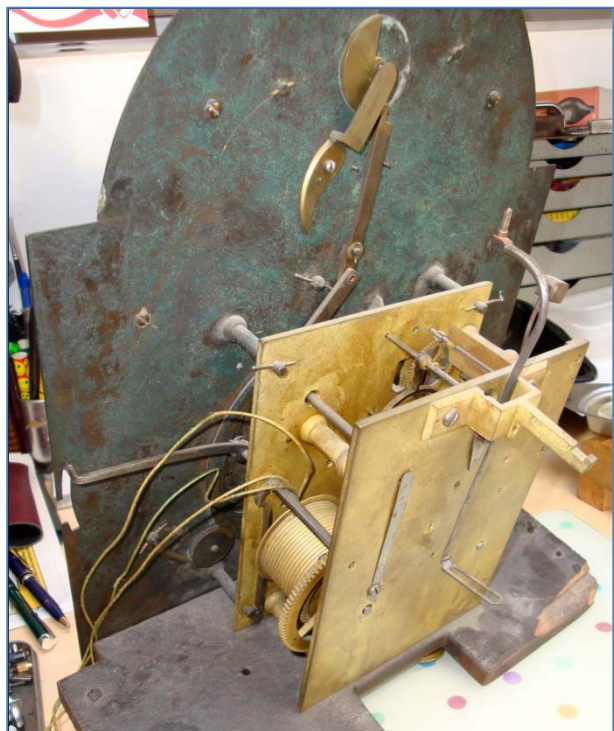
The longcase clock in question had not run for over 30 years; the owner wanted me to restore it to full working order and research the maker. When the clock came into my workshop in April 2010 it was in a very poor condition, several parts were missing, and the clock was suffering greatly from verdi-gris and brass stress fractures, both these problems needing urgent attention to conserve the clock for the future. The very nice quality English walnut case had, like the movement, been bodge repaired over many years of its life, some of these old repairs now needing further work. This clock was made in the 1740's; note the simplification of the dial for a new age of elegance.

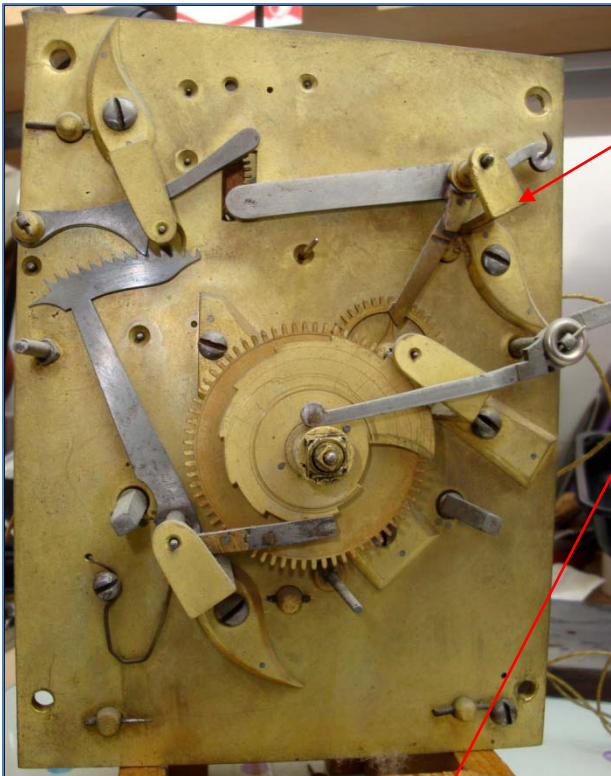
The first thing apparent is the use of comma foot cocks rather than the standard fixed steel mounting posts.

This method of making is very similar to Tompion and Graham's clocks. The plates are very thick and have five heavy pillars, unusually no pillar latches so characteristic of Grahams work.

Several parts are missing, a pull repeat return spring, maintaining power shutters, rack arm follower spring, calendar wheel and flag, also a rack return spring of the correct type.

Note the colour and hue of the brass, evidence of long immersions in ammonia based cleaning solutions during the past.

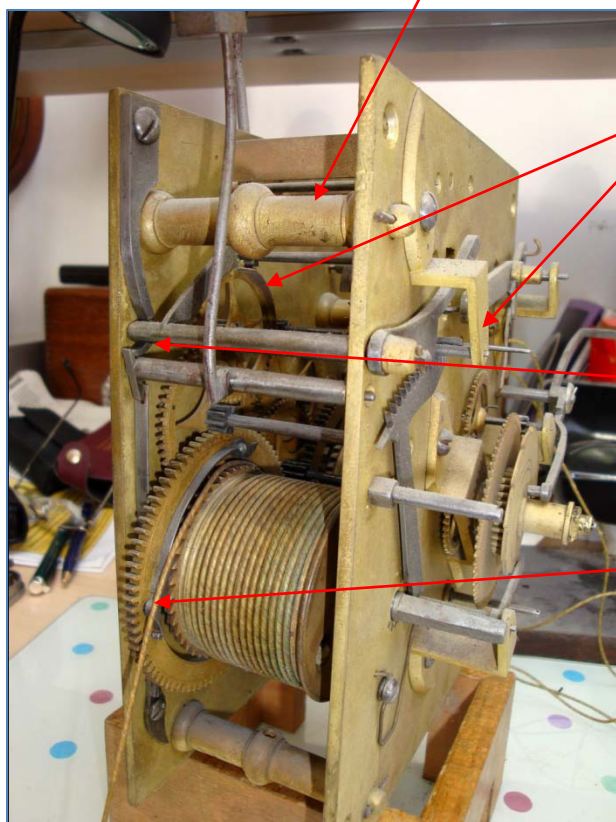
Note that the gathering pallet is one piece with the arbor. The strike has deep tooth locking into a stop on the hoop wheel, so typical of 30 hour clocks, rather than a just single locking pin.

The strike is quiet, the hammer force balanced so well between the hammer and stop springs.

Well made great wheel ratchet clicks with steel springs

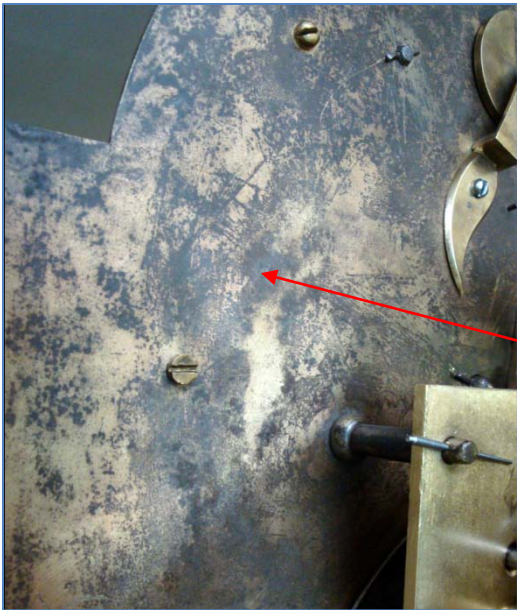
You will notice the green Verdi-gris on the back of the dial plate of this clock on page 1. This needs to be stabilised or it will cause further damage. Verdi-gris had also caused damage to the corner spandrels, having got underneath the original mercurial gilding.

Here we see a section of the back of the dial plate after the Verdi-gris has been removed and stabilised. The plate has then been protected by a coating of microcrystalline wax to seal the surface.

The darker patches are where the Verdi-gris had damaged the plate.

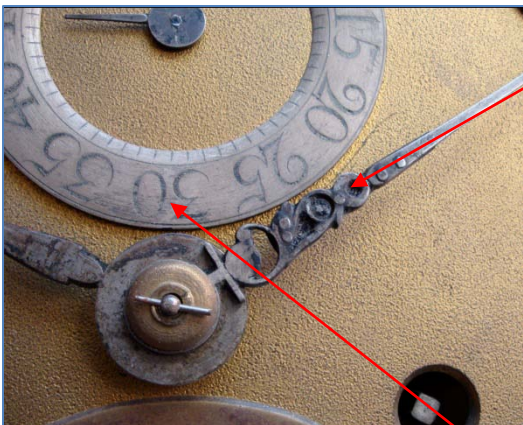
An example of an old repair, the minute hand had been broken and riveted together. A nice example of riveting maybe, but it all looked very heavy and spoilt the balance of the hand. This repair was removed and the hand was repaired with silver solder and re-blued. The silver solder was supported by shimming a piece of steel behind the damage.

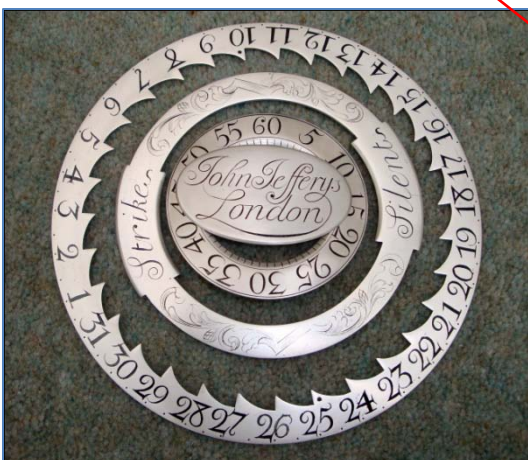
All the silver work, including the chapter ring suffered with loose and very grey black wax. The wax was removed and re-loaded and the silvering re-finished and clear lacquered.

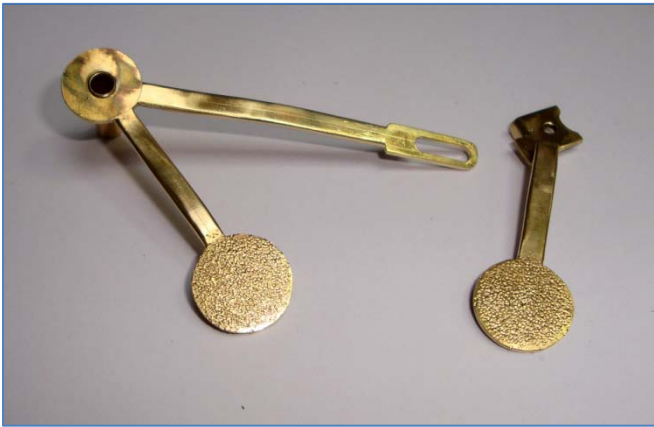
The maintaining power shutters were both missing, these are the new replacements.

The brass was chosen to match the dial plate colour as near as possible.

I signed and dated these parts to show they are none originals

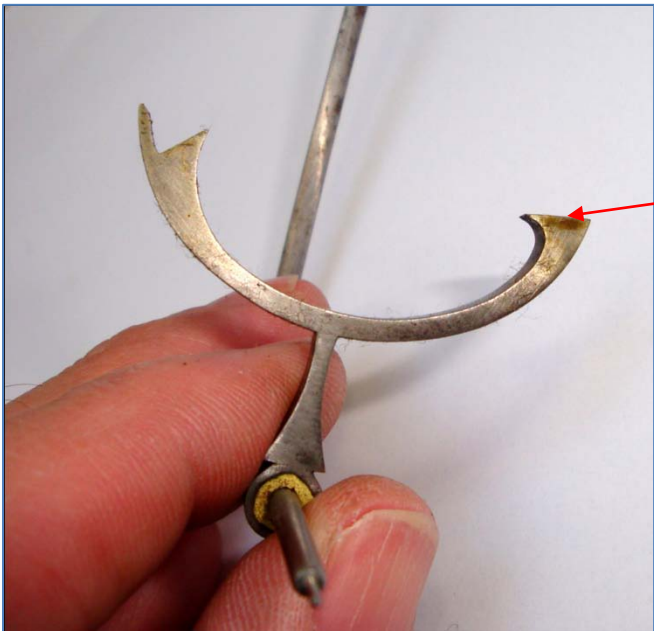
The escapement pallets on this clock are of the recoil type, it would be expected to find Graham dead beat pallets on a clock of this quality with maintaining power.

The pallet faces were worn and pitted, the faces restored with carbon steel micro welding and then adjusted. The action of this escapement is one of the best I have seen.

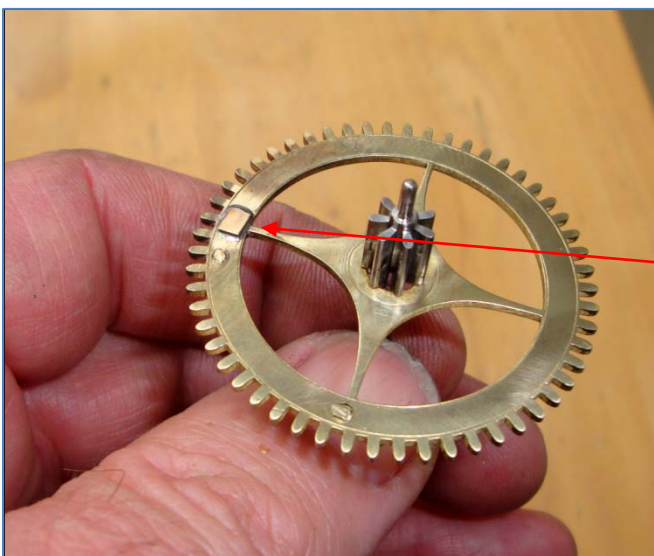
The sign of a good clock is the lightness of the crossing work on the wheels, this clock has very light wheel work but sometimes this can be a real weak point. The old Ammonia based clock cleaning fluids cause fractures in brass that can lead to failures of the wheel rim and crossing at the narrow point. Here a small brass patch is soldered on to support and strengthen a fracture crack in the rim of this wheel.

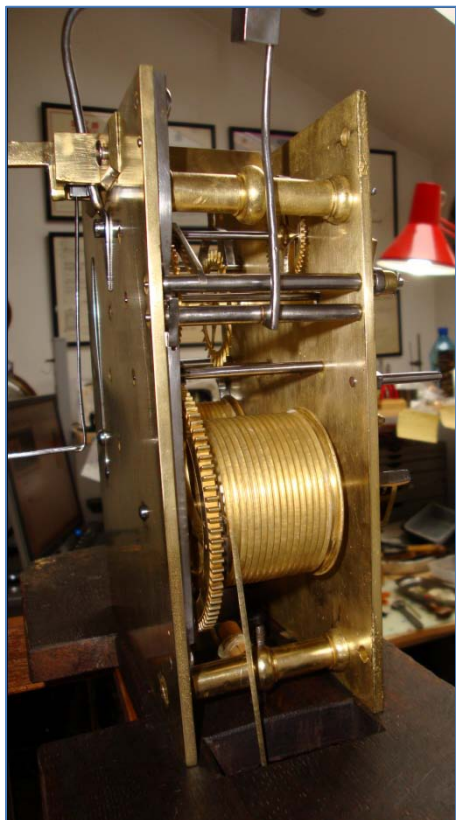
Here is a view of the strike side of the movement; you can see the difference after the repairs are completed. The steel work has been burnished.

As per good conservation practice I don't polish the brass work as this process does not add to the efficiency of the clock and does remove metal.

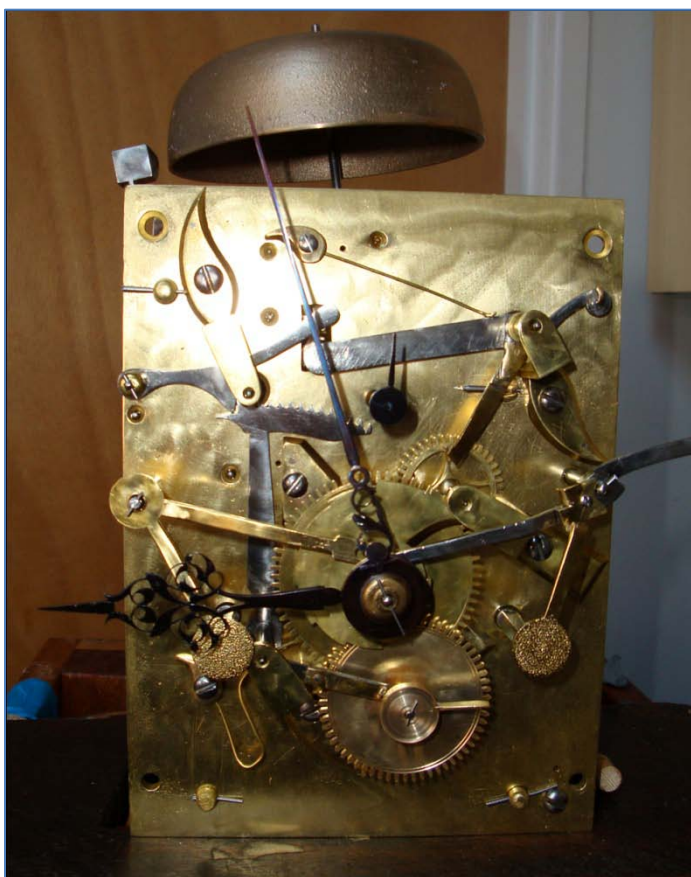
The movement now complete and under test. Note the repaired hands, and maintaining power shutters and calendar wheel are now restored. The slight difference in brass colour highlights these parts as new work and none original to the clock.

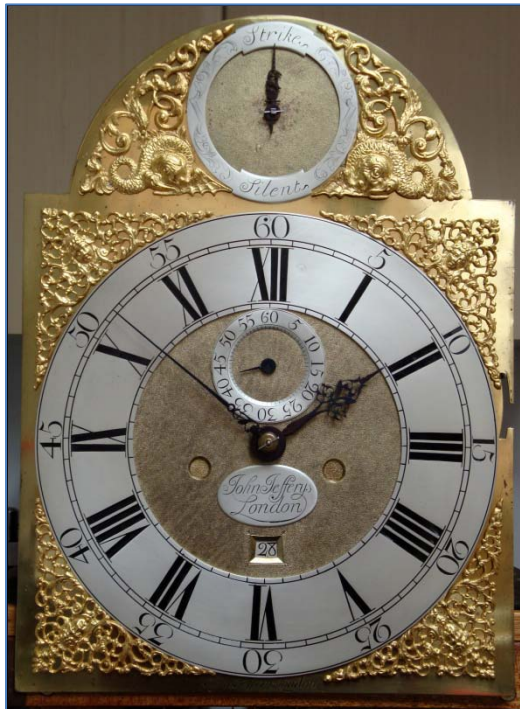
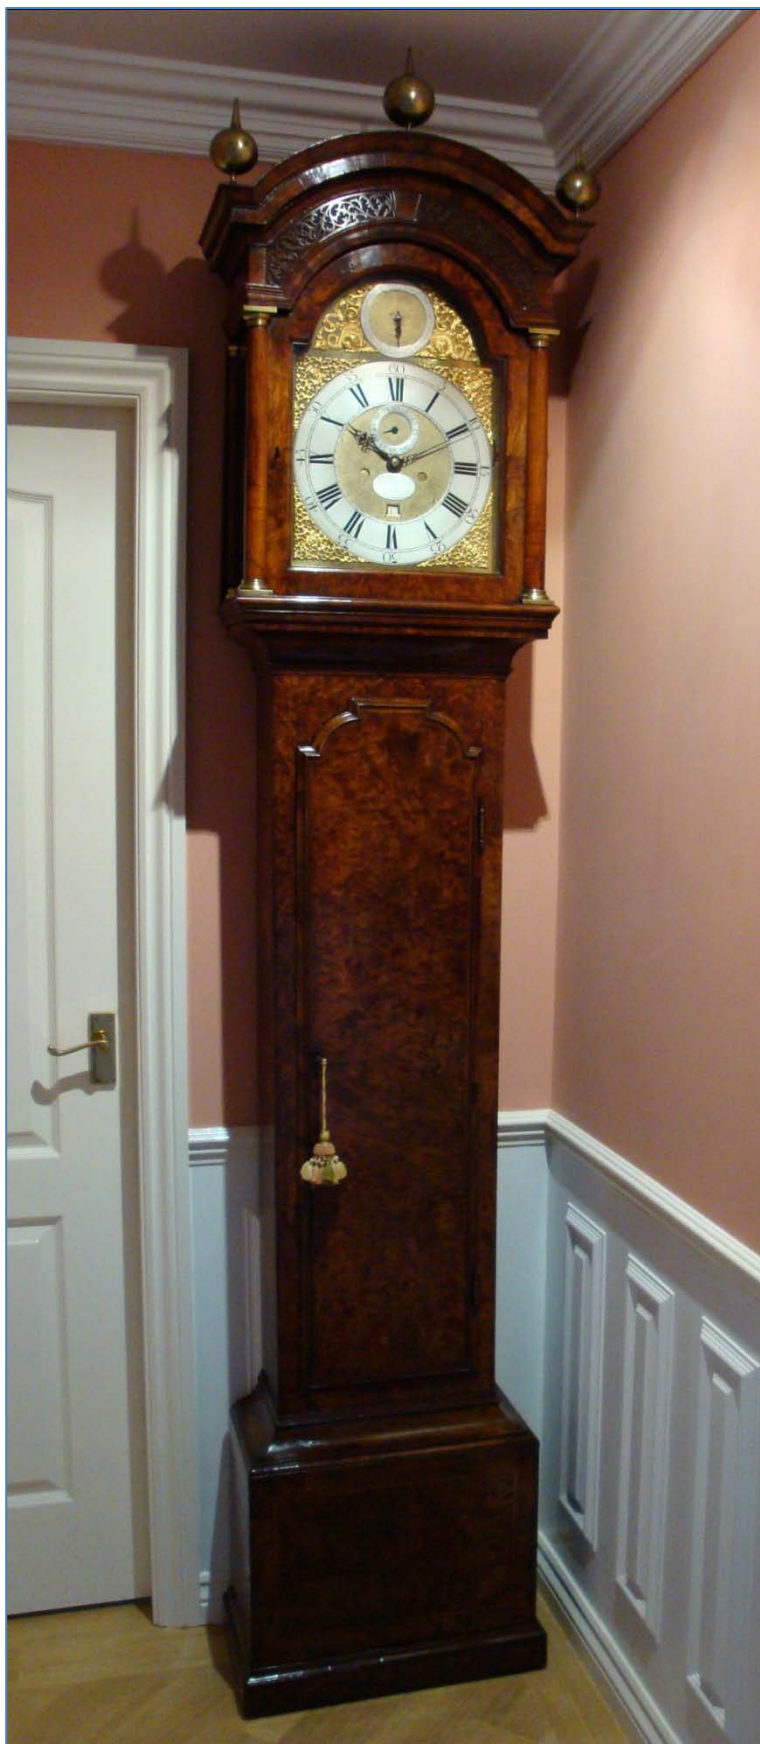
Here we see the clock complete and working again after many years and firmly fixed to the wall in my clients' home. The English walnut case is now looking resplendent after cleaning and repair.

Many repairs were made to this case, the hood needing quite a bit of work including the removal of the remains of a caddy top, replacement of the blind fret, missing brass capitals, repairs and re-fitting of loose veneers.

The trunk required re fitting and replacement of several loose mouldings; re hanging the door, and fixing and repair of some veneers. The colour has been much improved and finished in wax polish.
