Micro Laser Welding (MLW) is a process only recently used in horology and the repair & conservation of antique clocks. It has a number of uses; here we see it used to repair badly worn pinion leaves. Pinions are not easy to repair because of their inherently small size; broken leaves can be replaced, but this is difficult to do whilst maintaining the strength of the remainder of the pinion head. Using the MLW process enables the original pinions to be repaired and conserved; this avoids the normal method of replacing them and possibly the associated arbor, with new parts and changing the historical context of the clock for ever.

Here, I show an example of a recent repair completed in my workshop to a posted frame 30 Hr clock. The clock was suffering from severe wear on all five pinions which made the clock very noisy & unreliable in operation. The clock made by Peter Boyce of Beccles, Norfolk is a product typical of that area and was made in about 1740.

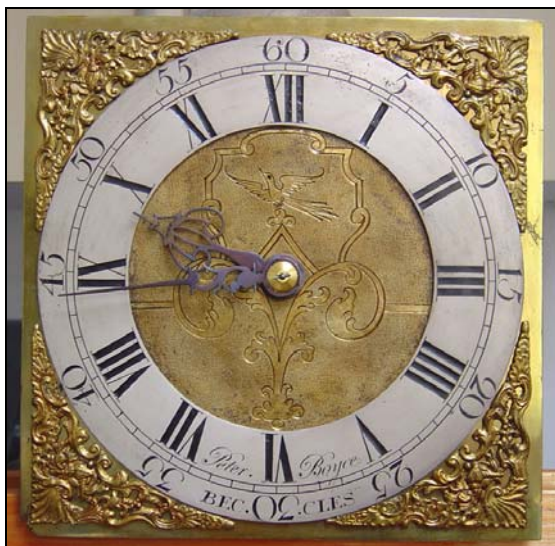
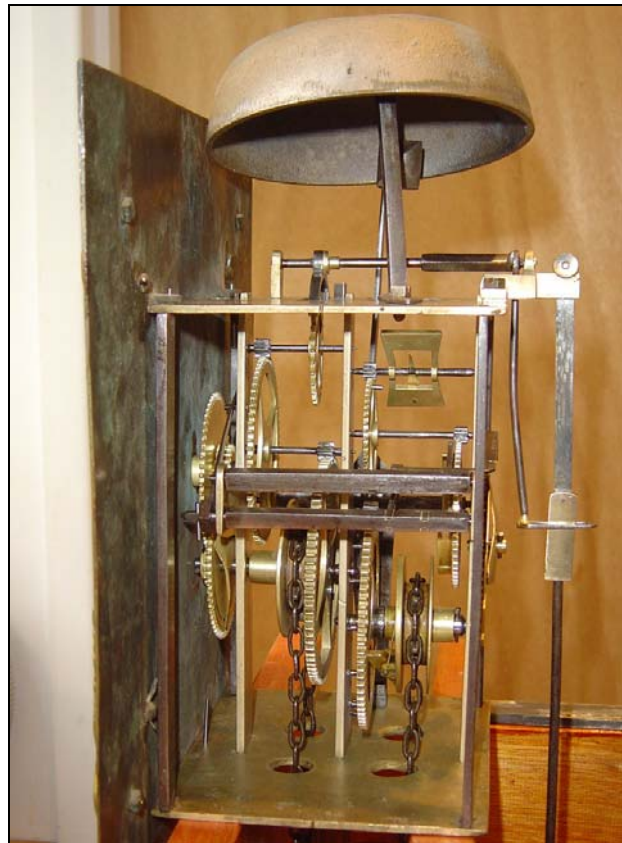
Right, we see the Peter Boyce, now clean & running with conserved pinions
