A 6-air cylinder music box by Nicole Frères of Geneva made in circa 1840

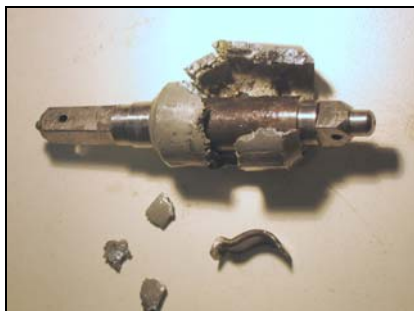
Here we see the white metal core of the spring arbor has fractured, most likely due to pressure, and the spring hook has come away. This could have resulted in severe damage if the hook had given way while the box was wound. The repaired arbor and new hook on the right.
