## An update on progress with the restoration of my Samuel Collier of Eccles Long Case Clock made in circa 1780

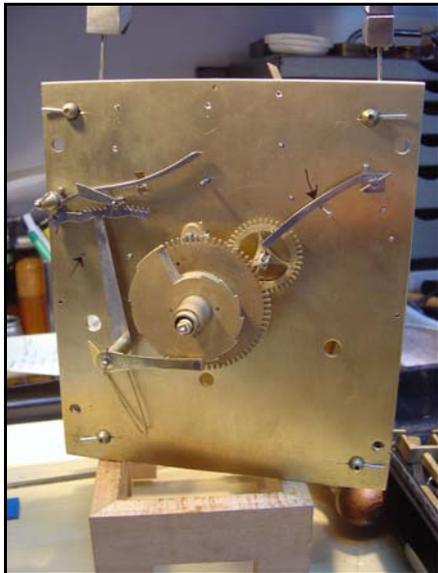
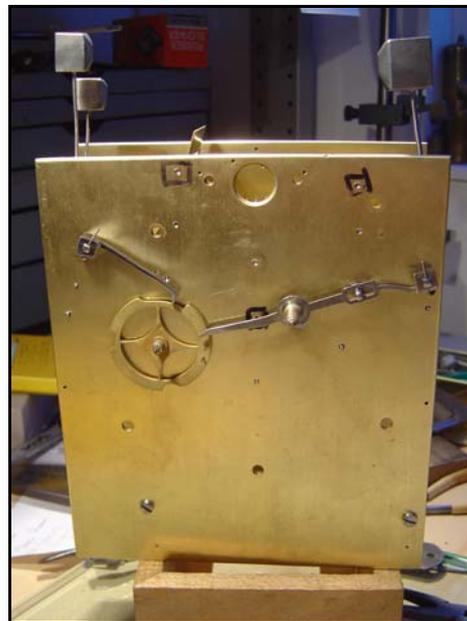
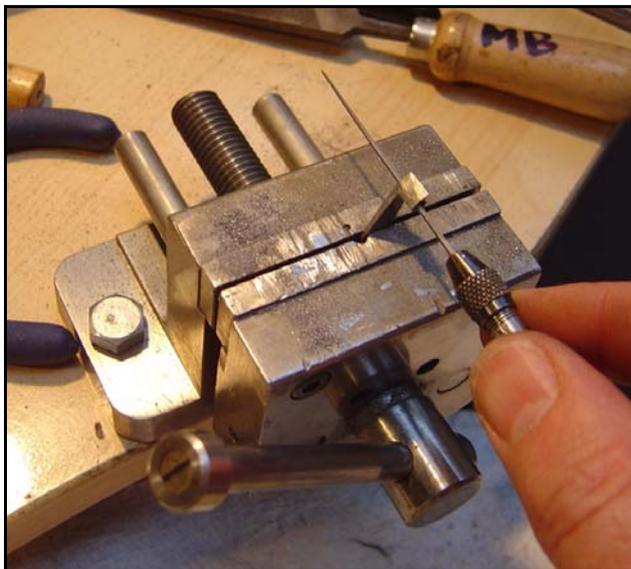
The original gathering pallet was badly worn and fell into two pieces while being removed. Left shows a new gathering pallet being made and adjusted.

Regarding the strike, the minute wheel lifts the lever and sets off the qtr train, the count wheel can be seen in the above picture. After the fourth quarter a detent is lifted by a pin on the count wheel, this puts the rack on warning and quickly operates the hour rack strike.

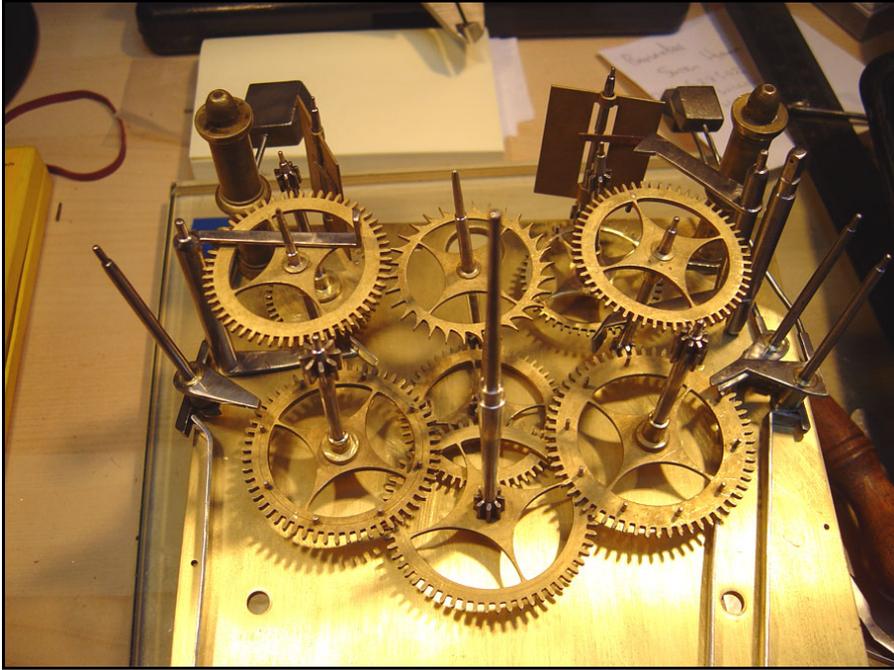
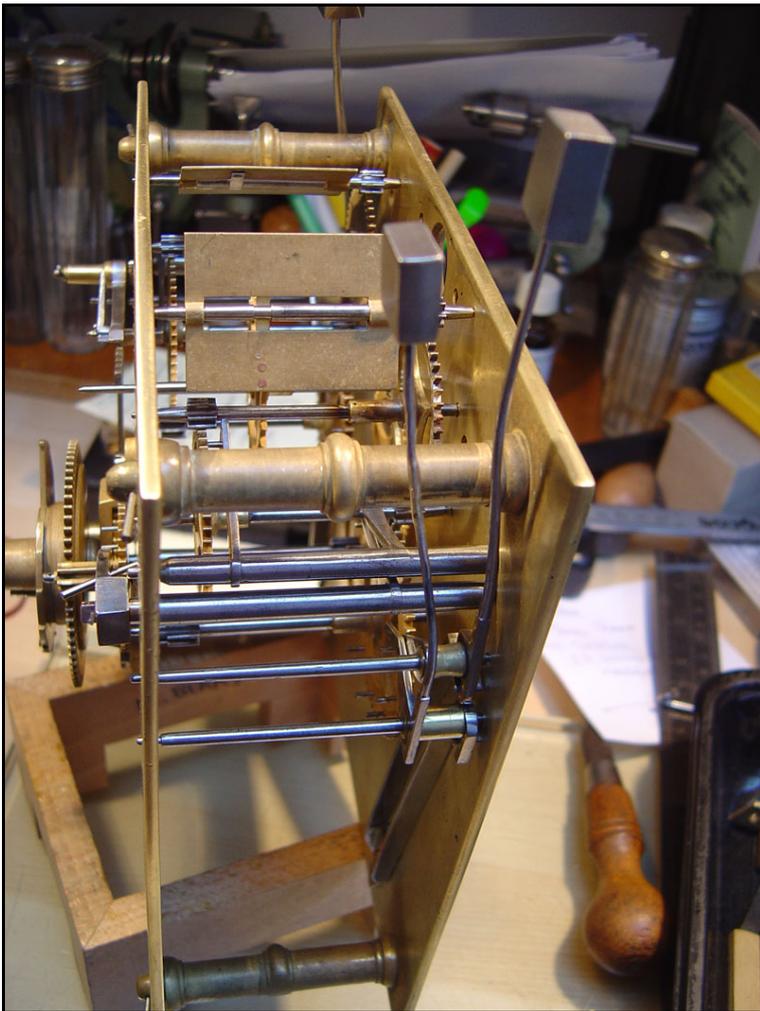
A side view showing the quarter train and hammers, the smaller hammer shaft had been poorly repaired and this was repaired.

Only two bushes were fitted, back of the second wheel and back of the strike fly arbors.

I repaired a fracture with soft solder on the qtr warning wheel and also tightened the collet.

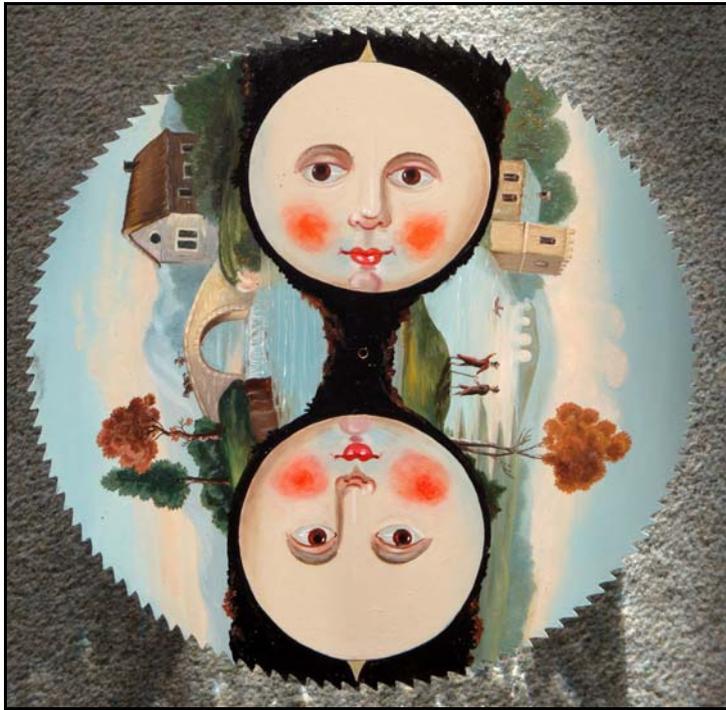
This is the replacement moon phase dial.

Note the typical long nose of the Manchester moons.

The original was in such poor condition that unfortunately it could not be restored. A new blank brass disc was made and the teeth cut, the dial artist Mrs Francis Tennant has faithfully reproduced the art work from the old dial and made a splendid job of restoring the dial.

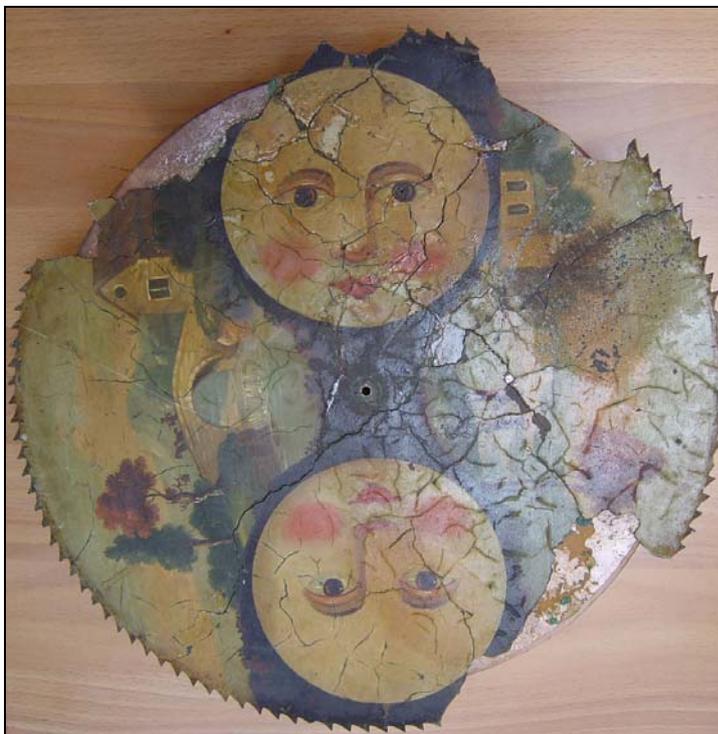
The original dial, showing the severity of the brass fatigue fractures. These discs were often made from poor quality off cuts of flat cast brass.

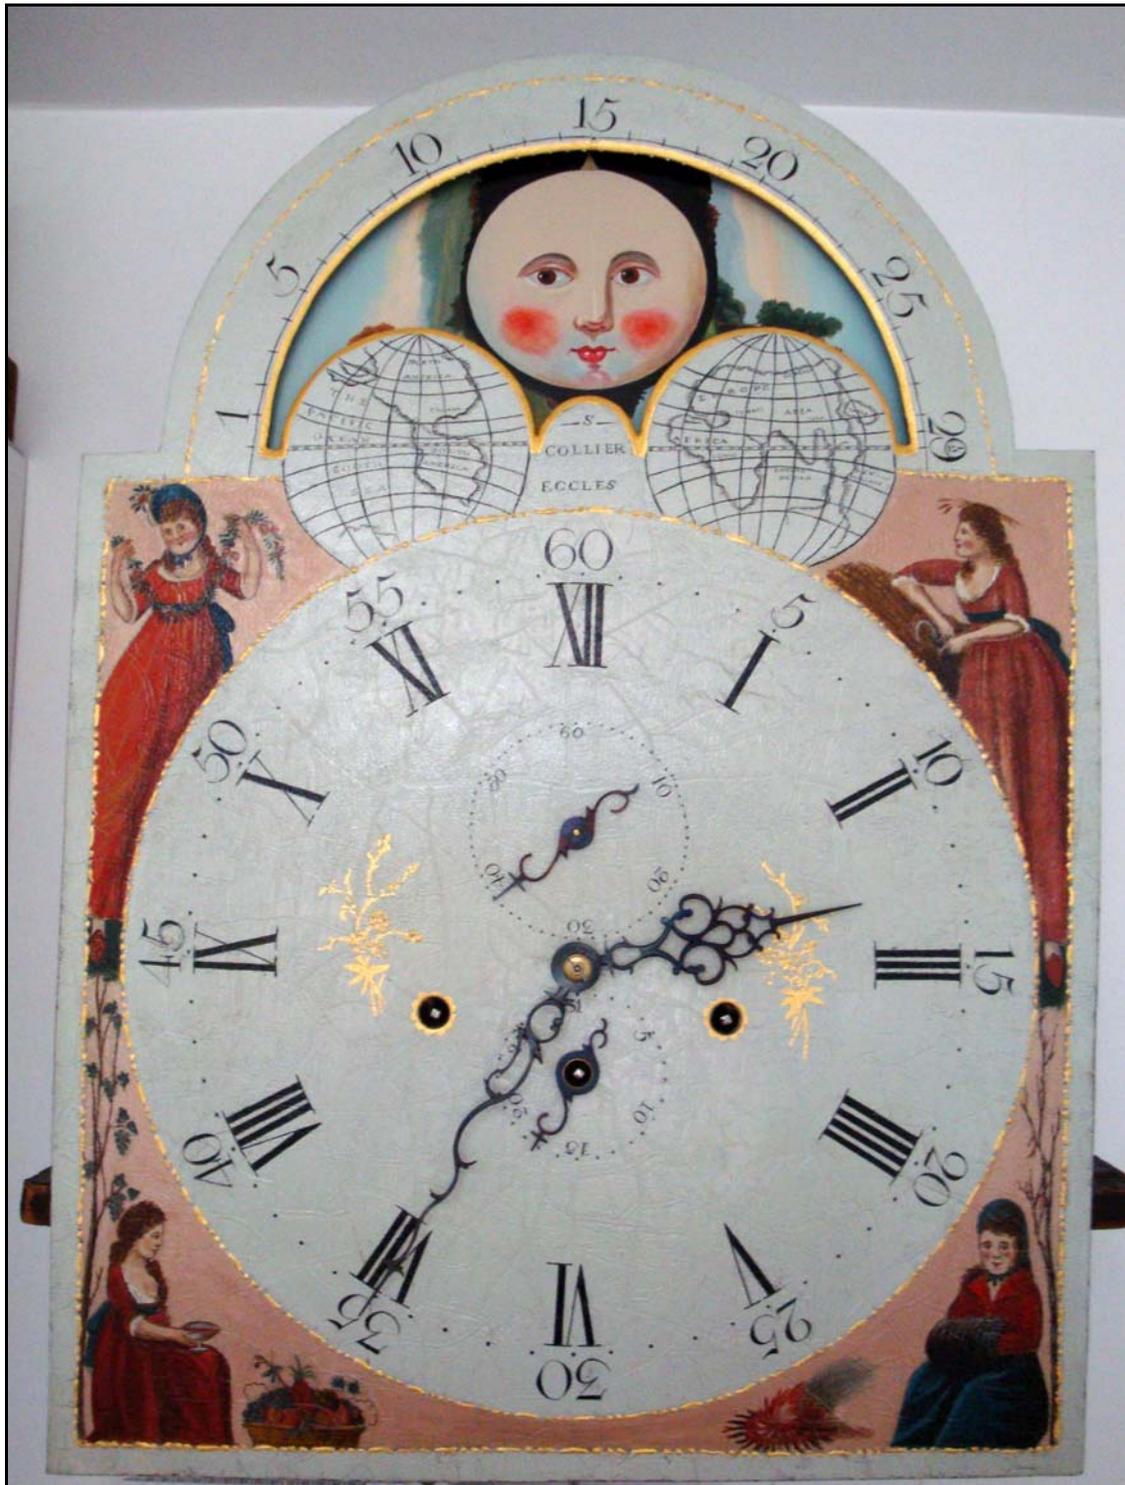
This is the largest Manchester dial currently recorded at 16 ¼", note the hand painted maps, the pink ground and Gesso work. The two bunches of Gold flowers and the painted winding circles are also typical. The original artist is a mystery but his work can easily be spotted and was only used by a small few of the Greater Manchester makers. See photos of the dial in an un-restored condition at:-
